Indian River County Home Inspection
Ron VanBuskirk
772-202-7003
ronv@indianrivercountyhomeinspection.com

4-Point Inspection Form

Address Inspected: 876 Spring Lake Dr. Sample Fl. 32958

Actual Year Built: 2020 Date Inspected: 7/6/2022

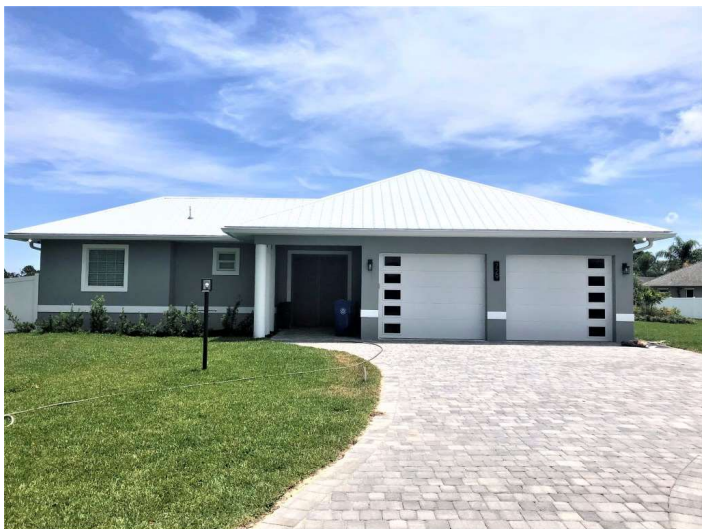
Front of home faces west

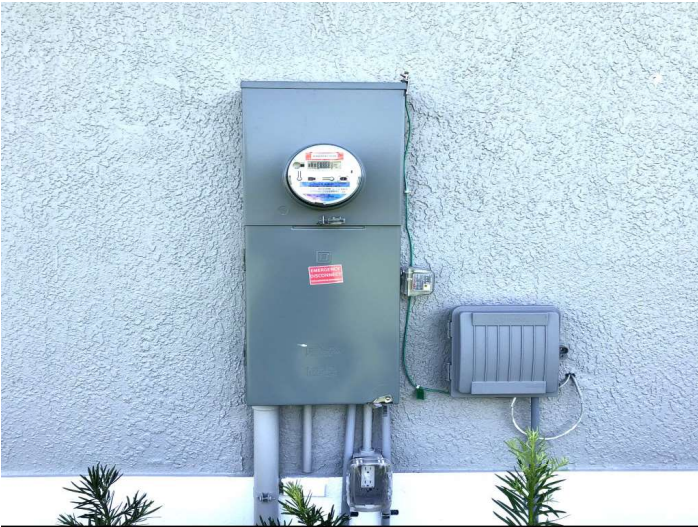
Main electrical service meter - power supplied by Florida power and light

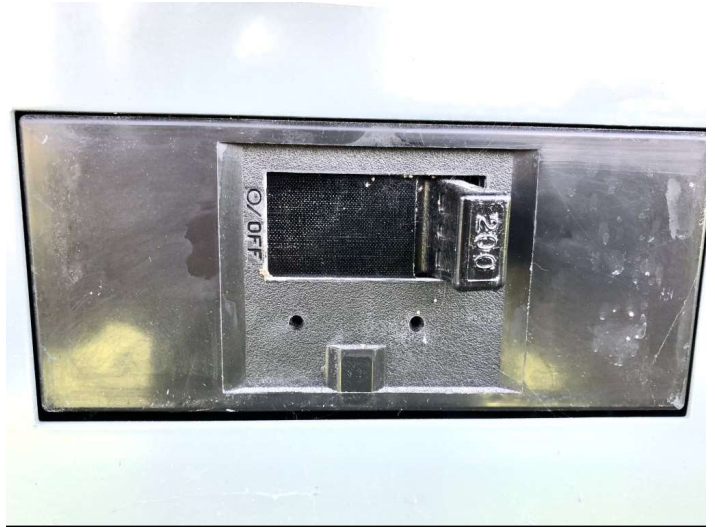
200 AMP main service disconnect breaker

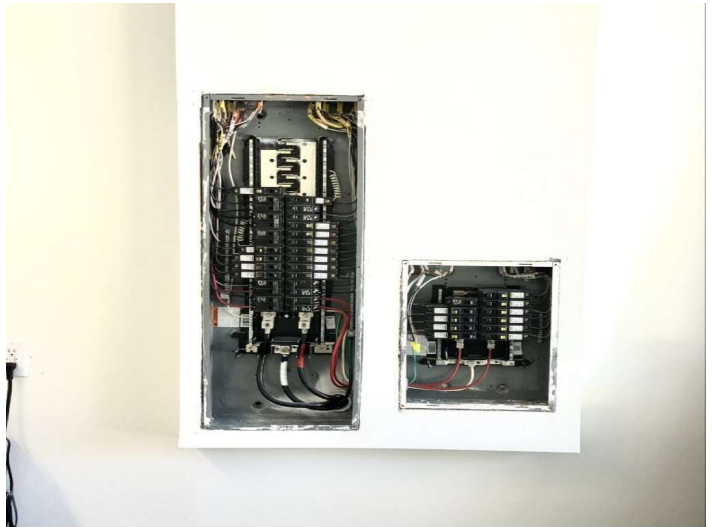
Electrical panels with covers removed

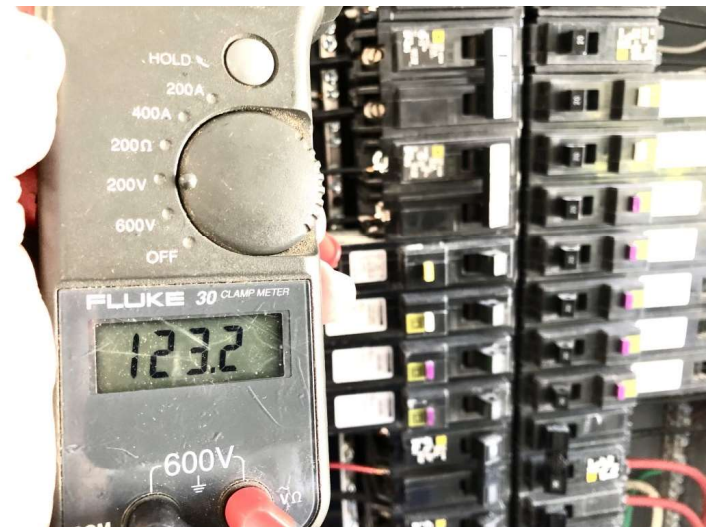
Main service panel voltage tested satisfactory

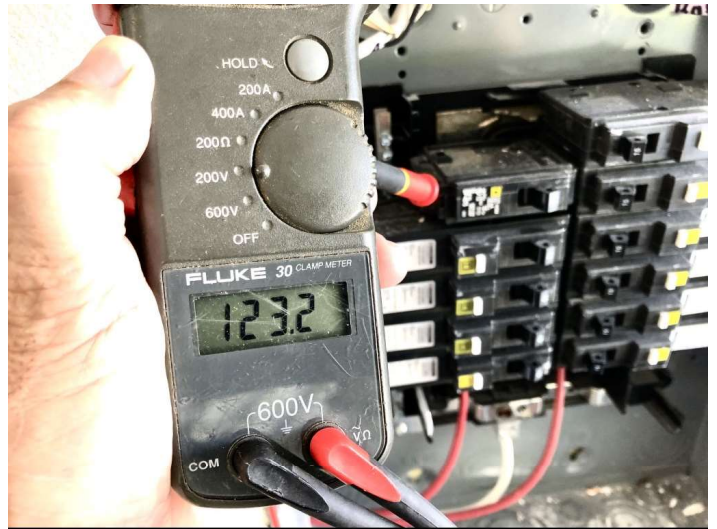
Sub service panel voltage tested satisfactory

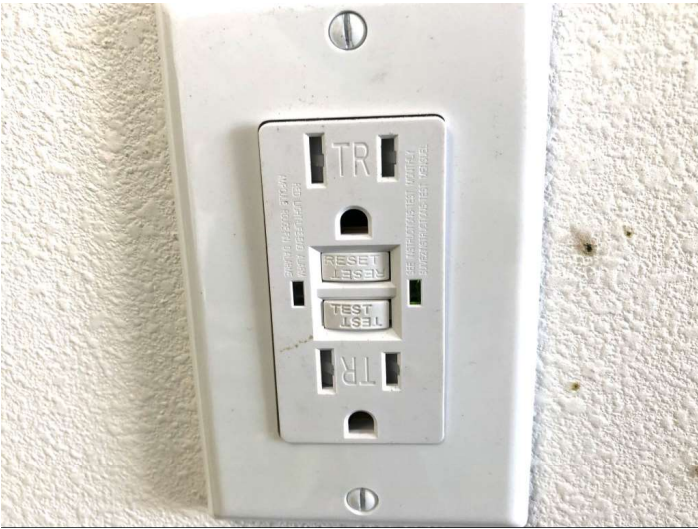
GFCI breakers located in all wet areas - Arch flash relay's located at breakers

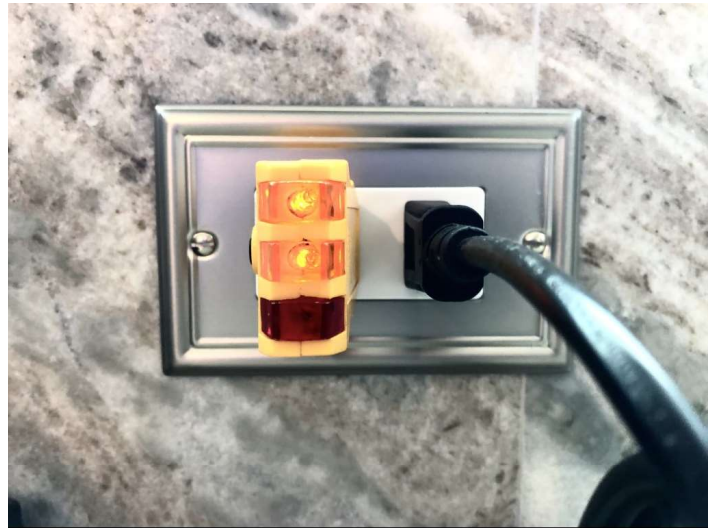
Polarity tested satisfactory at electrical outlets

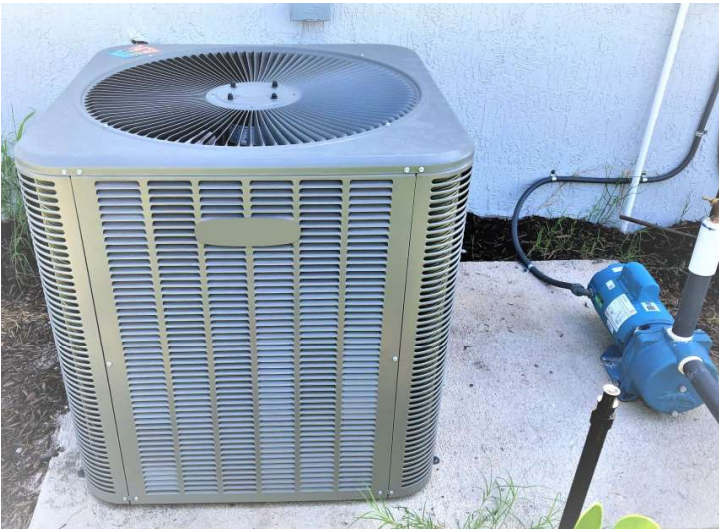
3.5 ton or 42,000 BTU outside air conditioning unit

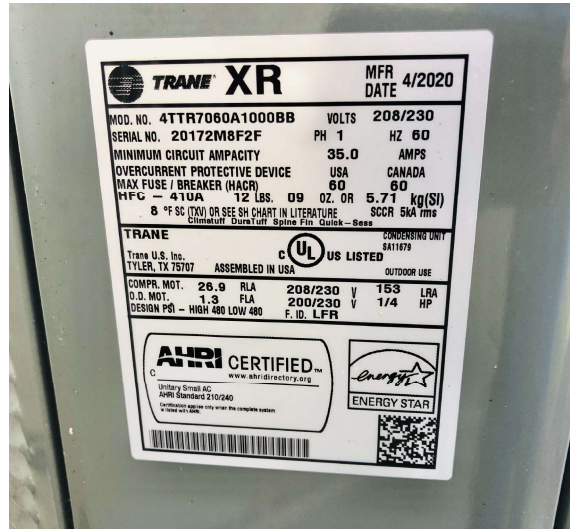
Outside air conditioning unit label - MFD 4/2020

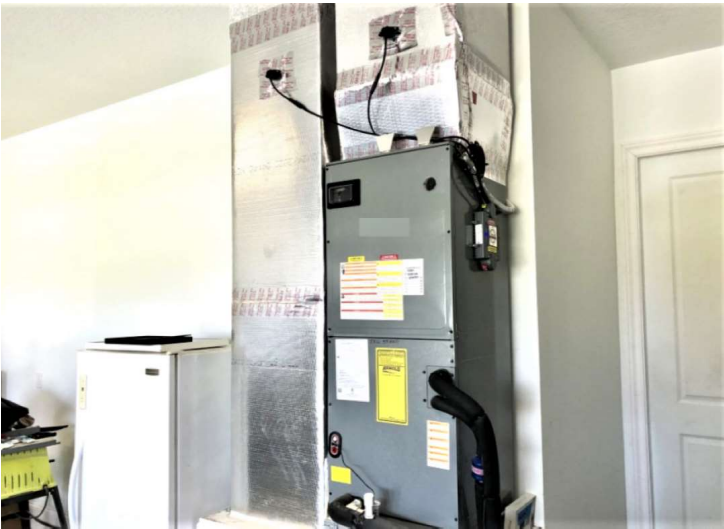
Matching air and heating unit located in the garage

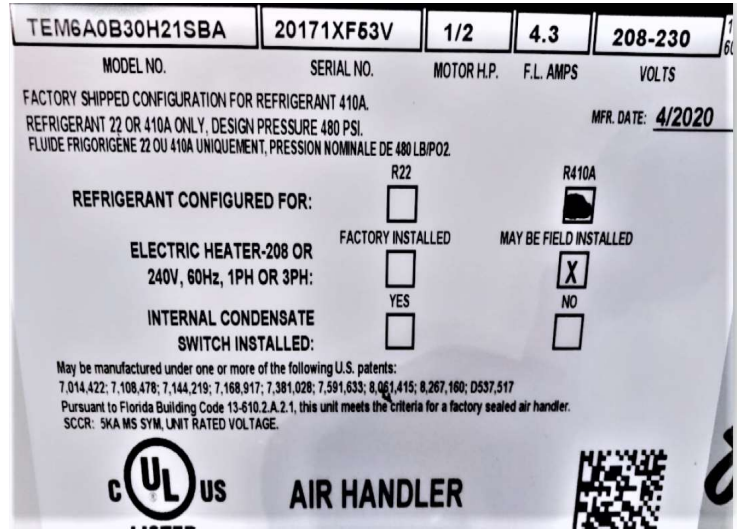
Air and heating unit label - MFD 04/2020

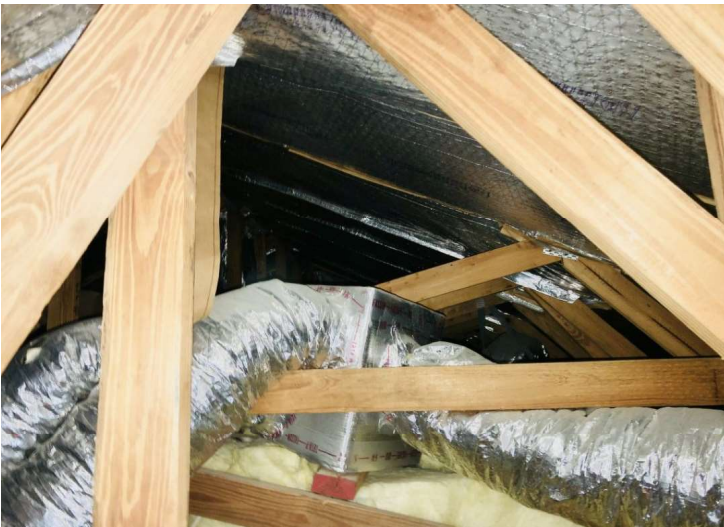
Attic insulation and air/heating ductwork adequate

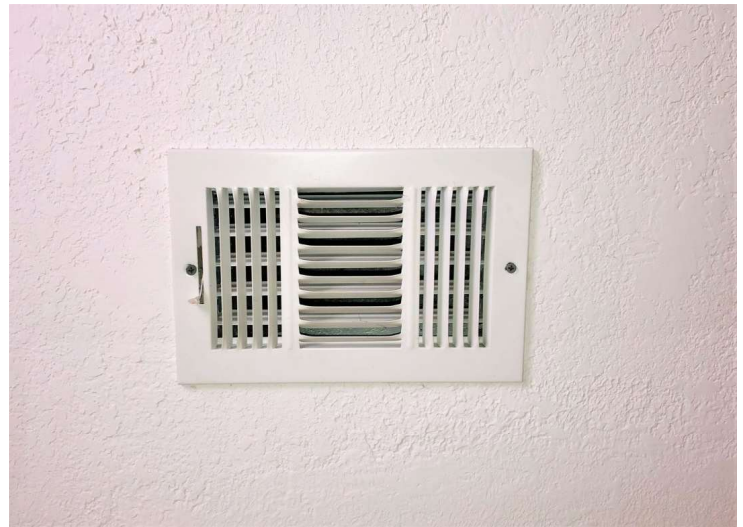
Air and heating distribution grills clean and in good working condition

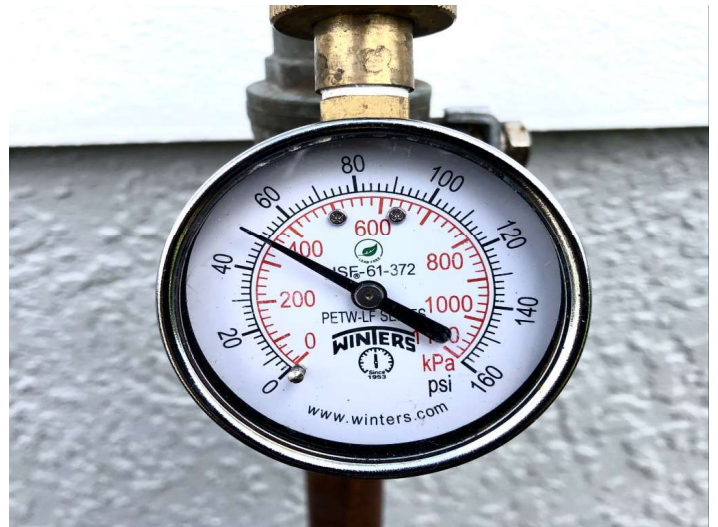
Water supply pressure to home - 50 psi (good)

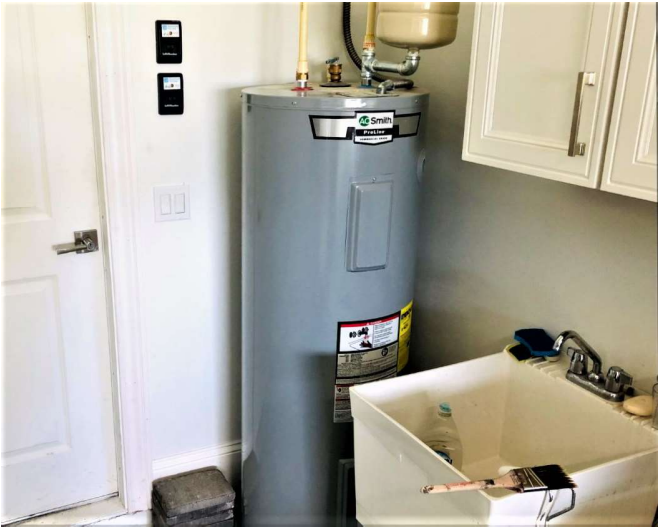
A.O Smith 50 gallon hot water heater

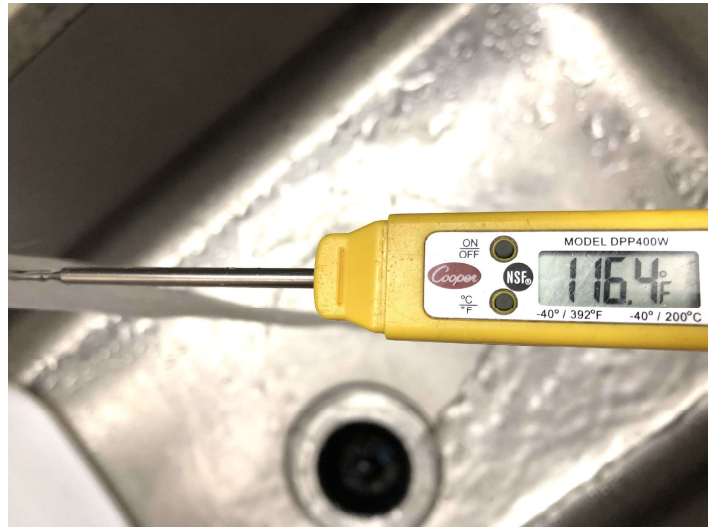
Hot water heater temperature 116.f (good)

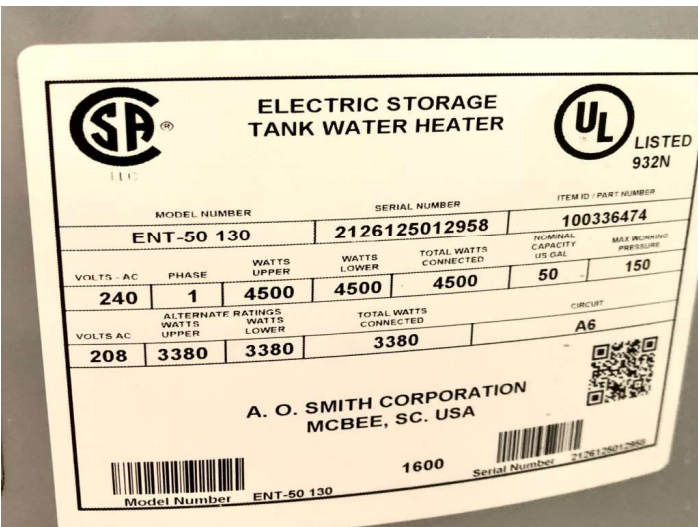
Hot water heater label - MFD 7/2020

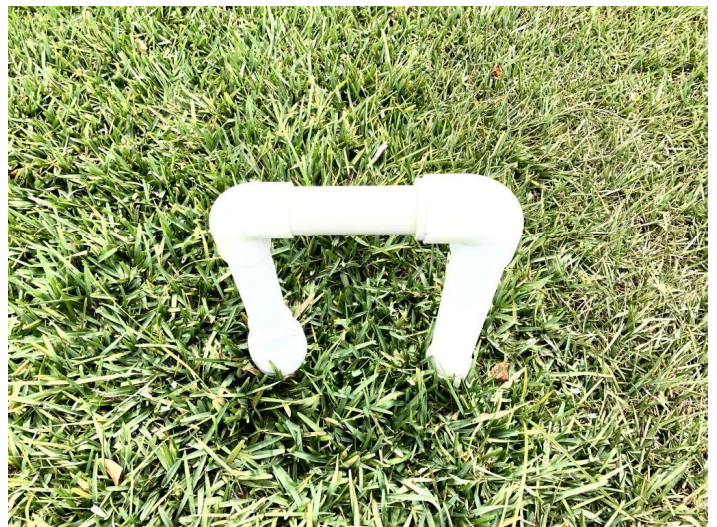
Well for irrigation located on property
